Manhole Inspection Summary

Manhole # S21UU1015MH

Insp Date: **3/29/07 10:23 AM**

Location Address: **5015 FALLS TERR RD**

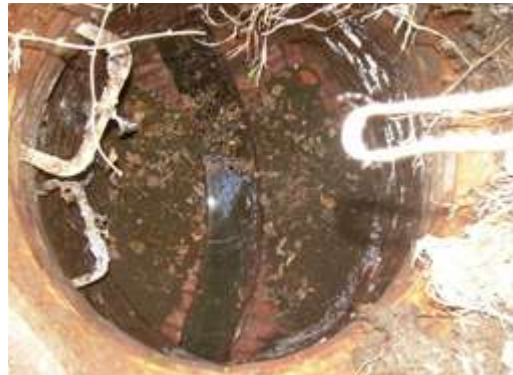
Top View

Bench ☒ Exists Material: **Brick** ☐ Parged ☒ **Debris** (not Condition related)

Channel Material: **Brick** ☐ Parged ☒ **Debris** (not Condition related)

Bench and Channel debris.

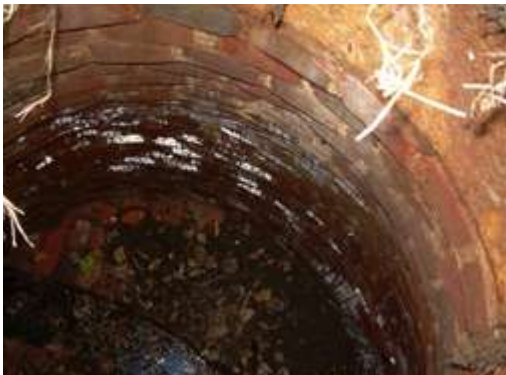
Defect

Infiltration: ☐ None ☒ **Joint** ☐ Cracks ☐ Mortar ☐ Roots ☒ **Wall**

Corbel and Barrel infiltration.

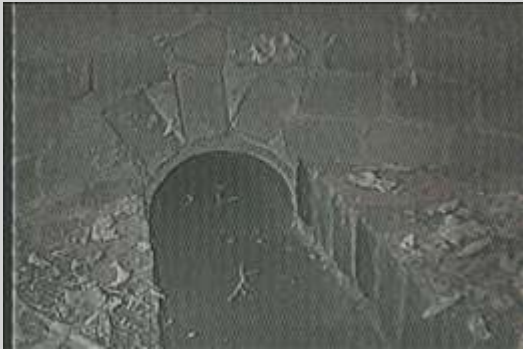
8 in. Circular Gravity Sewer Pipe Out @ 12 O'Clock

Deposits: ☐ None ☐ Mud ☐ Sludge ☐ Debris ☒ Grease

Silt Depth: **0** (in.) Deposits Extent: **Light**

Infiltration: **Evidence** Pipe Seal Cond: **Cracked**

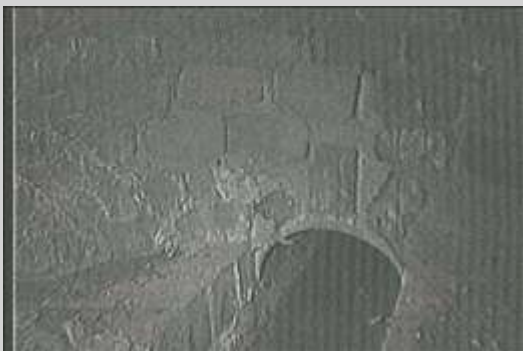
8 in. Circular Gravity Sewer Pipe In @ 7 O'Clock

Condition: ☐ Sound ☐ Cracked ☒ **Root Intrusion** ☐ Loose Brick ☒ **Deteriorated**

Infiltration: ☐ None ☐ Joint ☐ Cracks ☐ Mortar ☒ **Roots** ☒ **Wall**

Barrel deterioration, root intrusion and infiltration.
